INSPECTION REPORT  
19668 918 Crescent  
Imaginary (Rural) BC L8T 8K8

INSPECTED BY  
Dallas Peever  
CW Inspections  
CPBC License #  
78804

INSPECTION DATE  
📅 2024-01-01  
🕒 10:00 AM

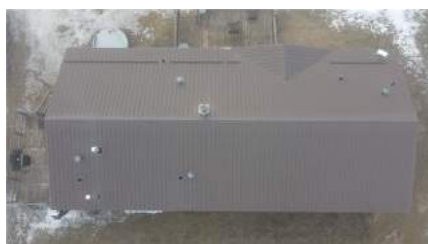
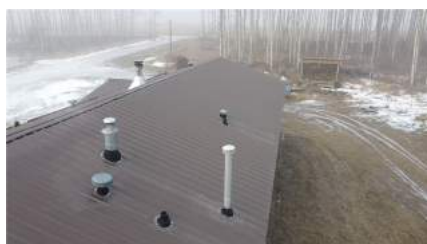
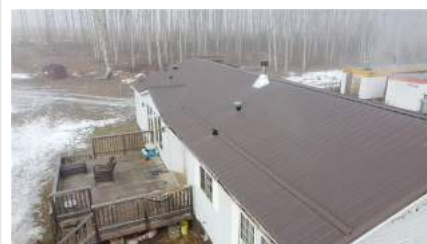
The roof coverings look to be less than 10 years old. They have a 50+ year life expectancy. This leaves approx 40 years of life left

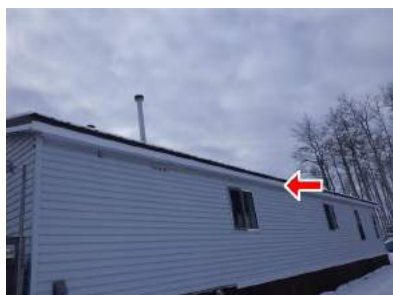
**1.3**  
North Side Of Building

There are no gutters or downspouts located on the north side of the building. This is normal for a manufactured home. The recommendation for this concern would be to add the rest of the gutter system

to the home. This will ensure the water drainage from the roof does not run down the siding and is carried the appropriate distance away from the structure.

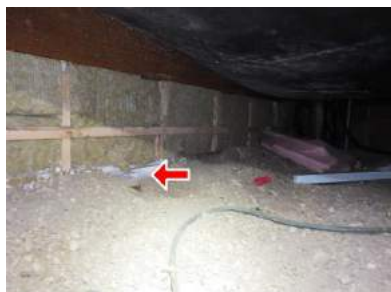
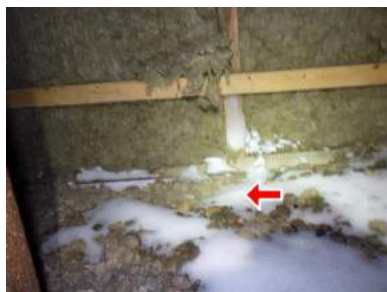
2.1  
Openings

(1) I found there to be some gaps under the skirting in multiple areas around the home. These gaps can allow for insect or animal ingress under the home which can lead to the possibility of damage to some of the systems. As well it will allow for heat loss from under the home during the winter months. The recommendation here would be to have a qualified contractor in to assess and repair these affects as the weather permits

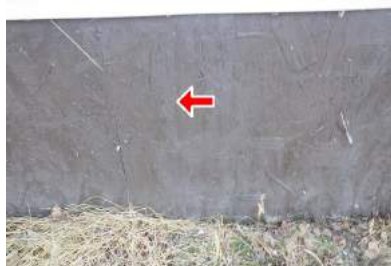
2.1  
OSB

(2) The skirt cladding is an OSB material. This longevity of this material is suspect in this application. Moisture will deteriorate this material faster than a preserved wood. I cannot be sure of the longevity of the system. The recommendation here would be to replace this skirting as needed in the future

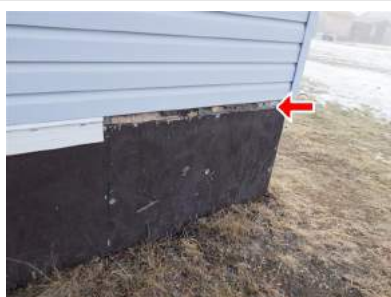
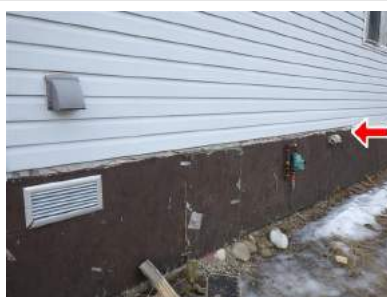
2.1  
Add Flashings

(3) There are a few minor areas with mechanical damage/missing flashings around the exterior cladding. These are maintenance concerns that if left too long can lead to moisture ingress and hidden damages. The recommendation is to have these areas repaired by a qualified contractor upon purchase of the property.

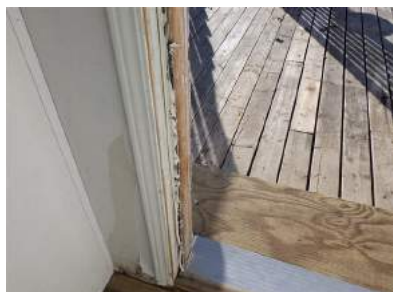
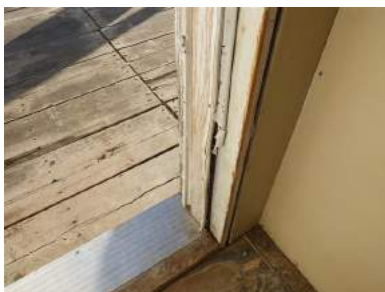
There was an air gap at both of the entrances. This is a maintenance concern that can effect the efficiency of the building. The recommendation for this affect is to adjust the doors accordingly and upgrade the weather stripping as needed

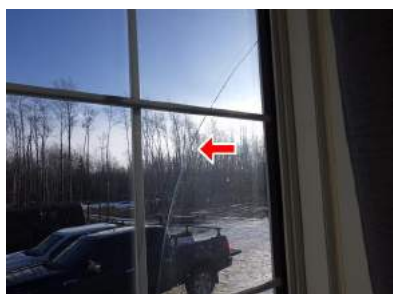
**2.3**  
East Window

(1) I found there to be a damaged windows in east end of the home. This is a maintenance/cosmetic concern. The recommendation for this concern is to repair/replace these damaged panes at your convenience.

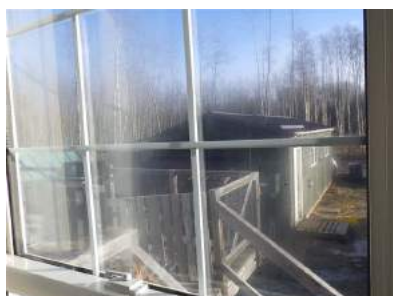
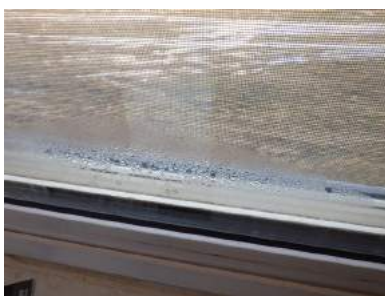
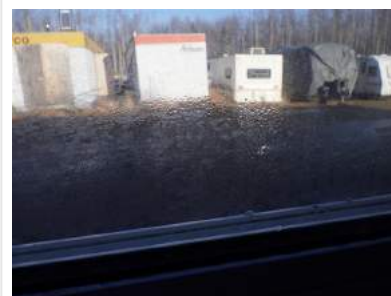
(2) I found that the glazing between the glass panes are failing at some windows. This is a minor maintenance/cosmetic concern. The recommendation for this concern is to repair or replace the failing windows at your convenience

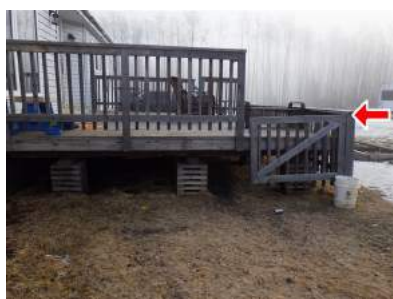
**2.4**  
Re-Install Handrails

(1) The posts for the handrails are completely unattached. This is a potential safety concern. I would recommend re-fastening these with the proper bolts and nut upon moving into the home

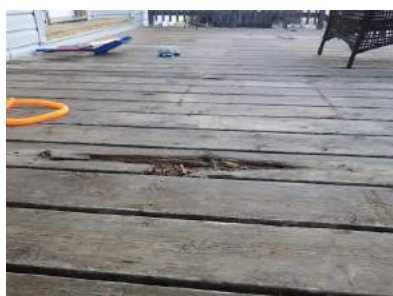
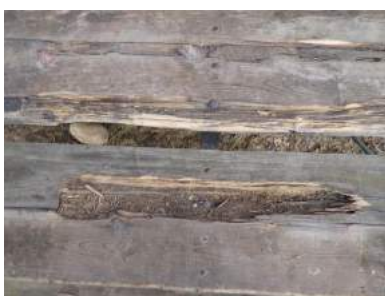
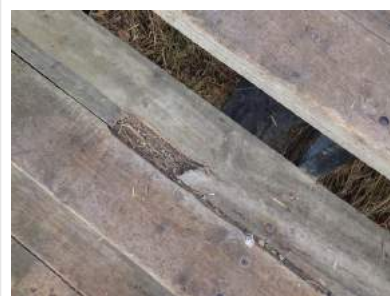
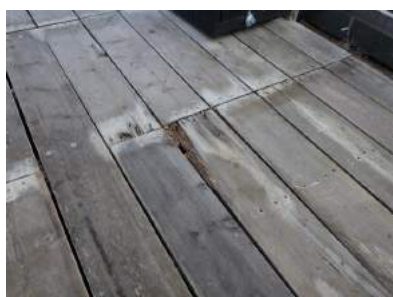
(2) I found some rot/deterioration to the decking around the exterior of the home. This is a maintenance/safety concern. The recommendation here would be to replace the deteriorated areas upon moving into the home

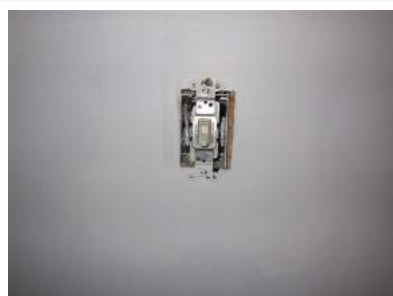
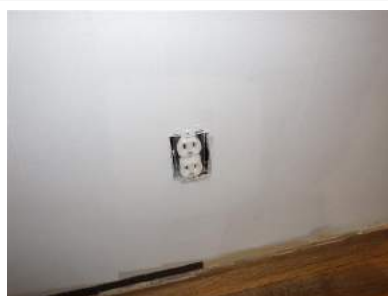
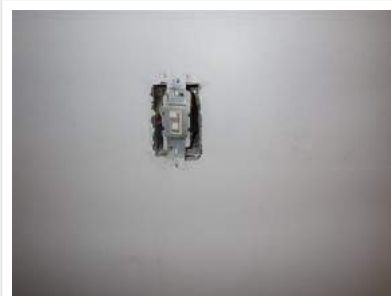
There are multiple cover plates missing throughout the home. This is a minor safety concern. The recommendation for this affect is to replace all missing cover plates upon moving into the home

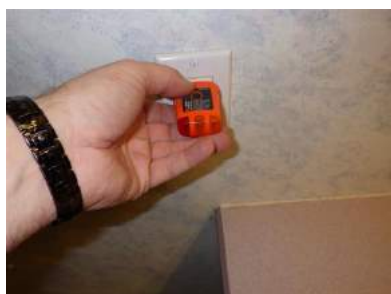
**4.4**  
Not Resetting

The GFCI receptacle at the master bathroom was not functioning properly. This is a minor safety concern. The recommendation for this concern is to have a qualified contractor in to assess and repair the damaged receptacles upon moving into the home

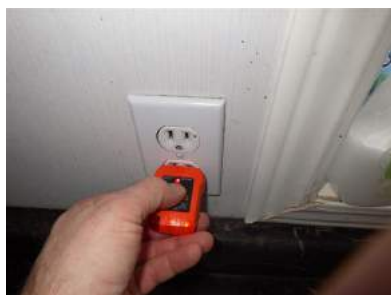
**4.5**  
Kitchen Receptacle

I found there to be no GFCI protection in the kitchen within 6 feet of the kitchen sink. This is normal for a home of this age. Although this is not needed to be done, the recommendation is to replace these standard receptacles with a GFCI protected receptacle upon moving into the home. This fairly inexpensive upgrade will bring the electrical system in this area up to today's standards

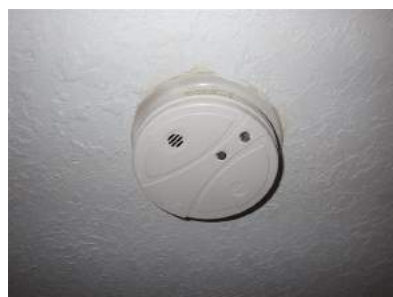
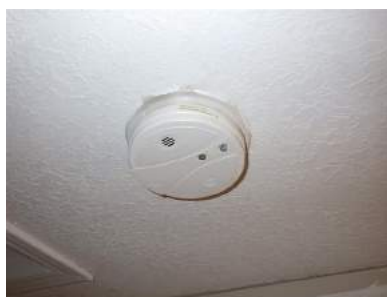
**4.8**  
Replace 2026

The smoke detection on the property is up to date and should be tested at all common areas, hallways and bedrooms upon moving in to home. Another recommendation is to add a carbon monoxide detector to any area that has a gas appliance located in it. Eg. HWT, Furnace, Gas Stove, Gas Fireplace

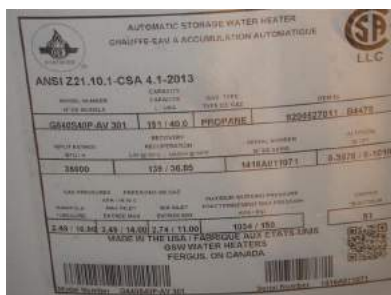
**5.2**  
Data Plate

The HWT has a manufacture date 2014. This system has typical life expectancy of 10-15 years depending on your insurer. The recommendation here is to replace as instructed by your insurer

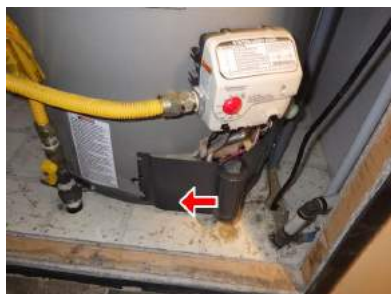
**5.3**  
Add Floor Pan

(1) The floor pan was missing from under the HWT. This is an installation concern and if the system fails, a tank leak could damage the finishes and structure of the home. The recommendation is to add the missing pan to the system upon moving into the home

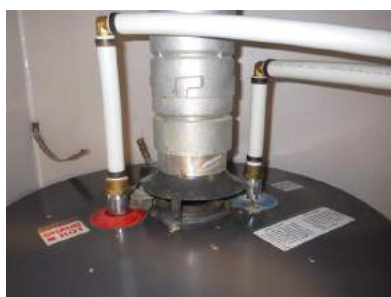
**5.3**  
Improper Materials

(2) The plumbing supply material at the top of the HWT was made from a PEX material. This is improper and could lead to a potential leak in the future. The plumbing material directly above a gas HWT should be made from copper for a minimum of 18 inches to deal with the heat from the system. Copper supply lines will deal with heat better than the PEX material. I would recommend replacing this plumbing upon moving into the home

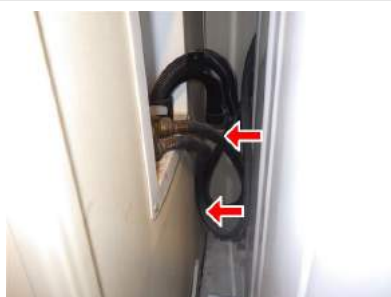
**5.3**  
Washer Supply Lines

(3) The supply lines for the washing machine are made from rubber. These do have a tendency to crack and leak over time. Although this is not a necessity, the recommendation is to replace these lines with a steel braided line upon moving into the home. This is a minor cost that may save you a major headache

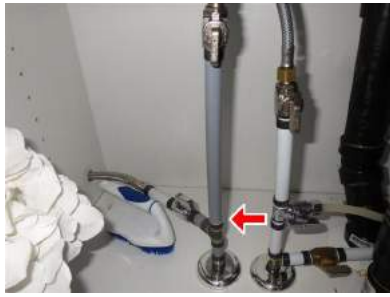
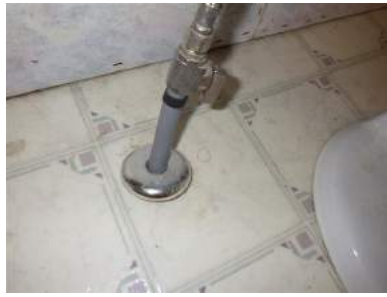
**5.3**  
PolyB with Copper Fittings

(4) I have located POLYB plumbing supply throughout the home and it does contain the proper copper fittings and crimps. I did not locate any areas on concern with the piping at the time of the inspection. This can be a possible insurance concern. I would recommend talking with your insurer prior to purchasing the home.

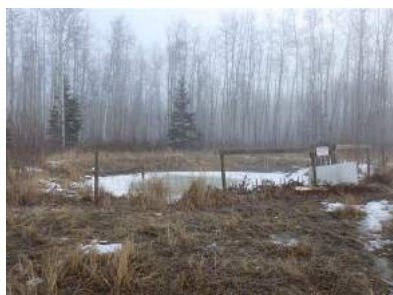
**5.9**  
Lagoon

There is a lagoon located on the property. Inspection of a lagoon goes beyond my scope of inspection. I would recommend that this area is fenced at all times

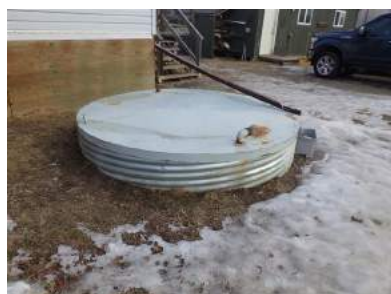
**5.10**  
Cistern

Inspecting these systems goes beyond my scope of inspection. The recommendation for these systems are to ask the homeowners the size of the cistern and if it is on a fill schedule. It is also recommended to have the system cleaned upon moving into the home. Any system that I do not inspect has the possibility of hidden damages or missing components

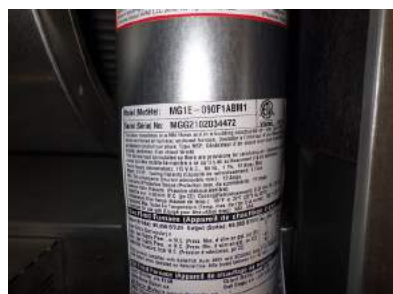
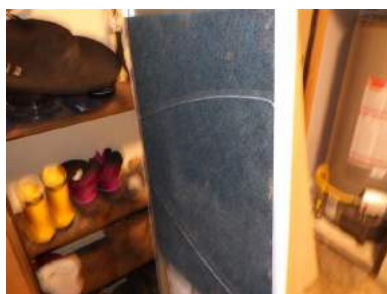
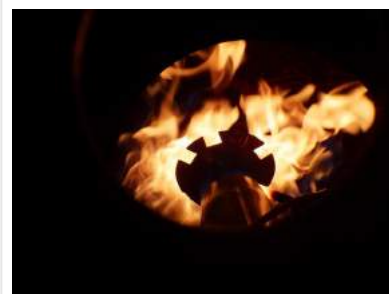
The heating system has a manufacture date of 2021. These systems typically have a life expectancy of 25 years. The recommendation for this system is to have it serviced yearly by a qualified professional and as well to change the filters every 3 months. This will add to the efficiency and longevity of the system

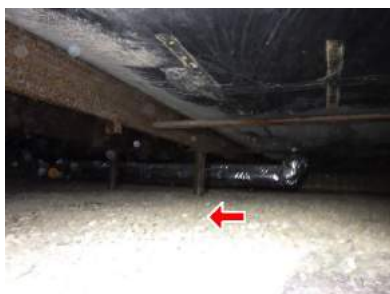
7.2  
Missing

The vapor barrier (plastic) on the crawlspace ground is missing. A vapor barrier provides added protection to the floor system from moisture or dampness that can enter from ground. A qualified person should repair or replace as needed.

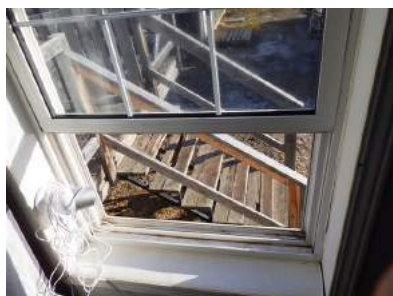
**8.8**  
Missing

There were multiple window screens missing throughout the home. These are minor maintenance concerns. The recommendation for this affect is to replace the missing screens at your convenience

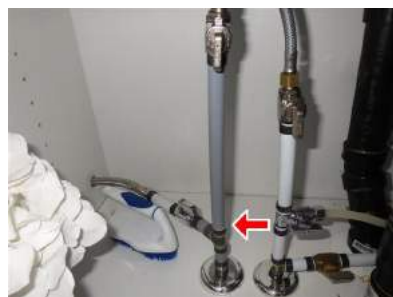
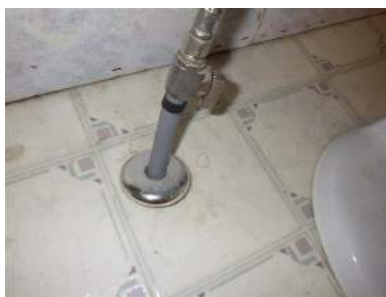
**5.3**  
PolyB with Copper Fittings

(4) I have located POLYB plumbing supply throughout the home and it does contain the proper copper fittings and crimps. I did not locate any areas on concern with the piping at the time of the inspection. This can be a possible insurance concern. I would recommend talking with your insurer prior to purchasing the home.
